# South American River Case Study

# **HULL CORROSION**

### South American River Case Study

Rupert Steer

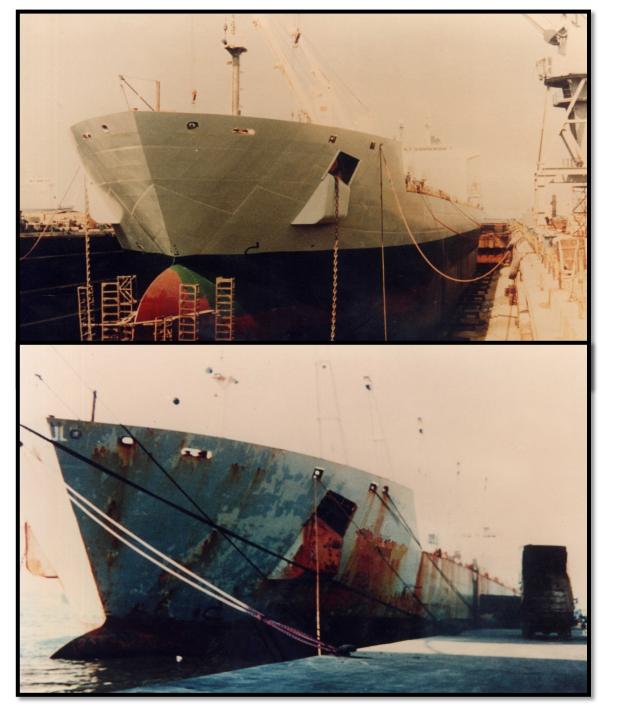
# COATING LOSS

Quality
Contaminants
Application
Mechanical

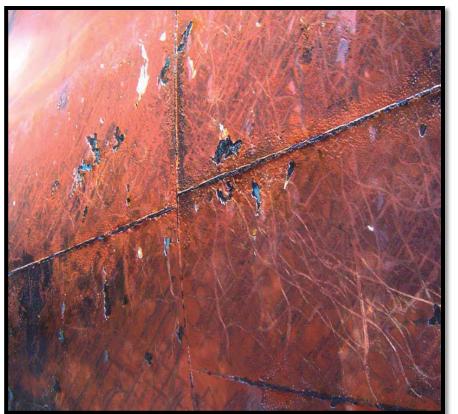
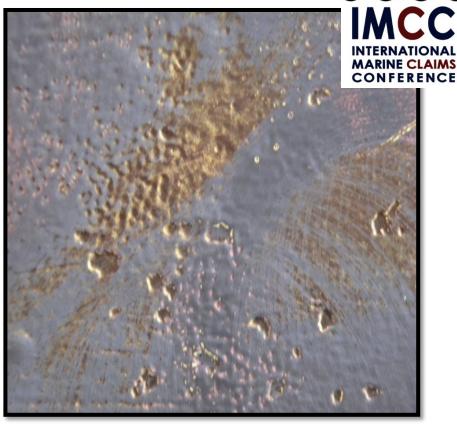
VIETNAM

Thi Vai River

SURINAME River

### PATTERN OF REMOVAL

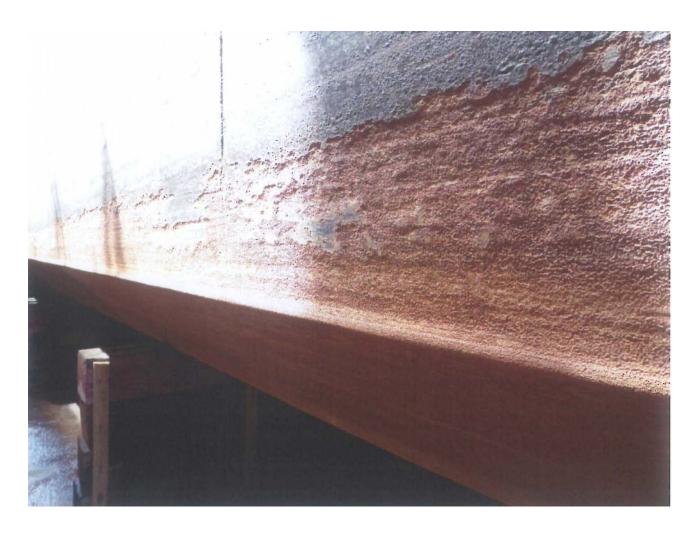
### SHELL PLATE THINNING

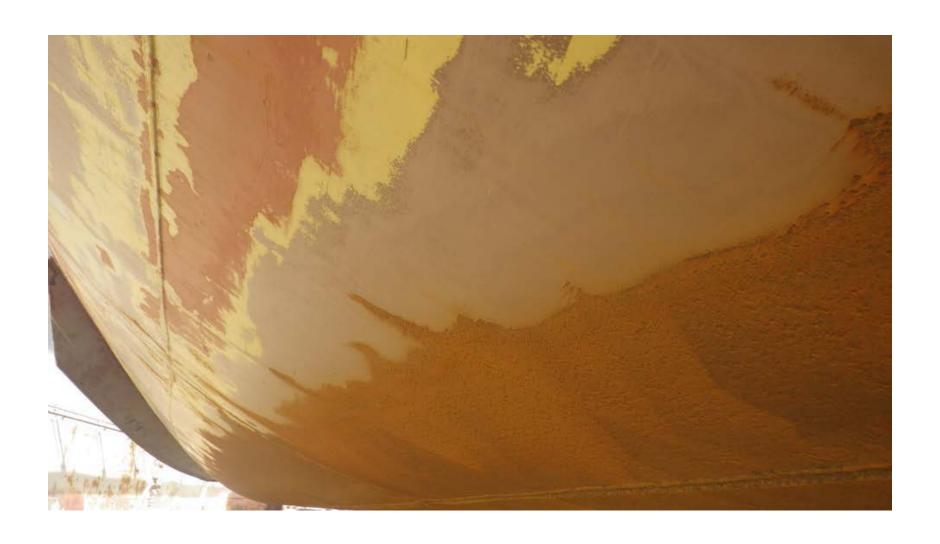
# **COATINGS LOSS**

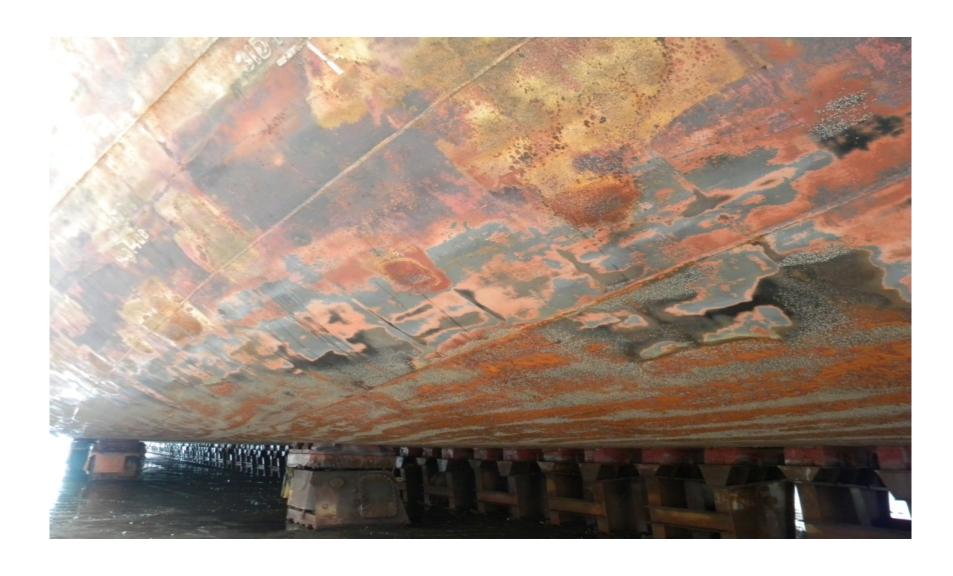
# **HULL CORROSION**

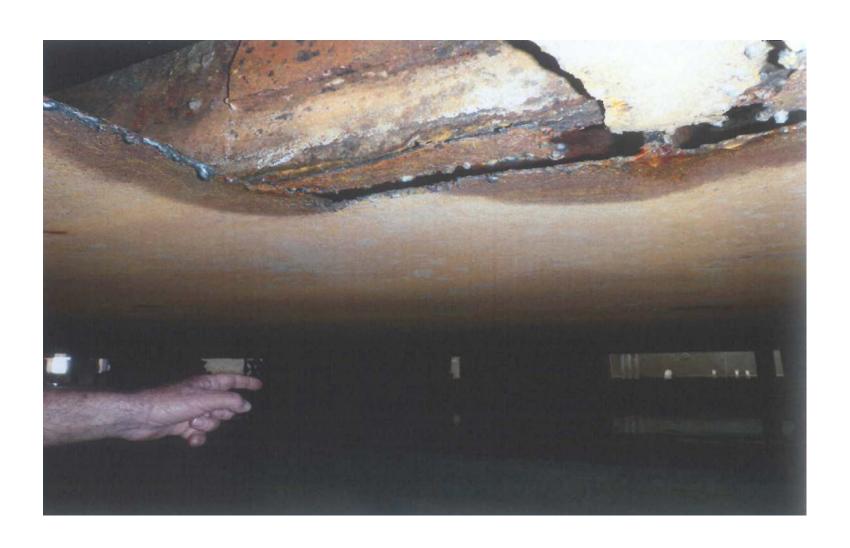
# THE RESULTS

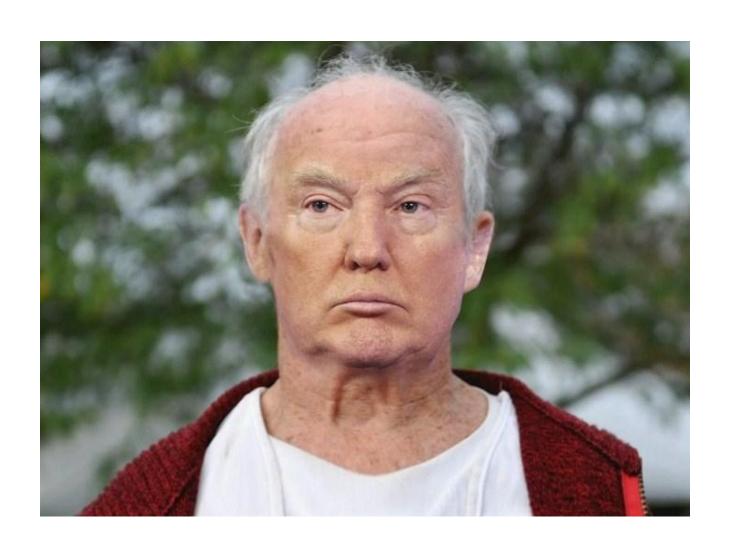
### AFTER ONLY 4 YEARS
