WORKSHOP 2

PORTS AND TERMINALS

“COAL CARRIER MAX” approach
to the Port of Belfast

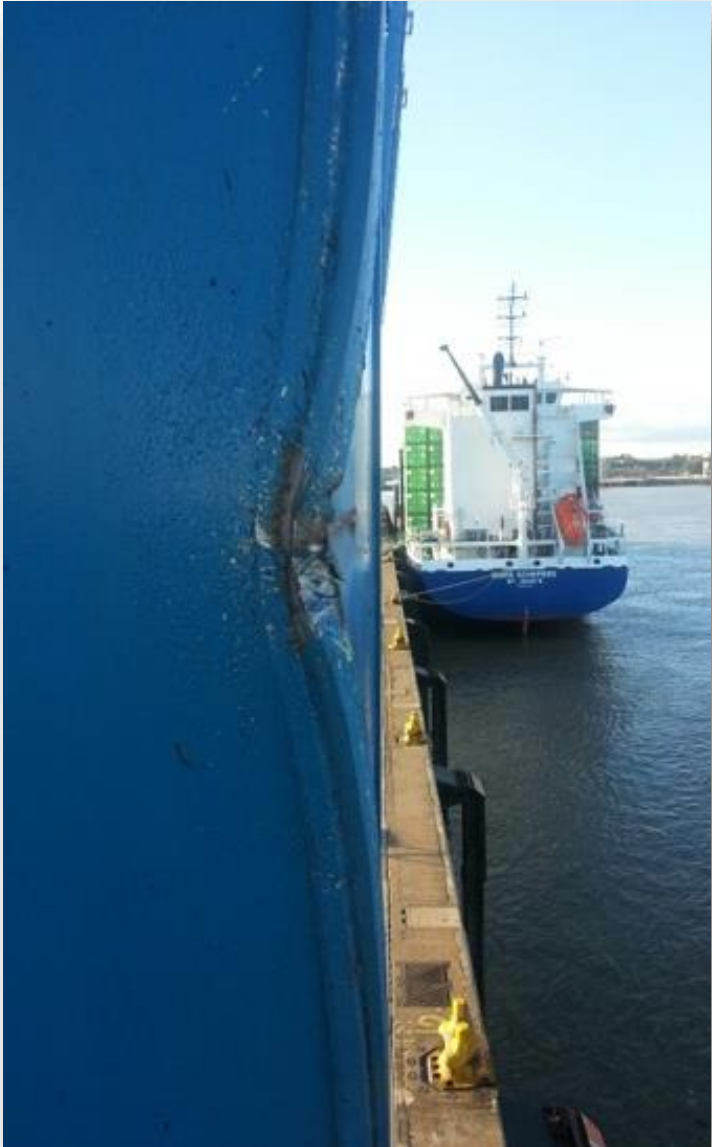
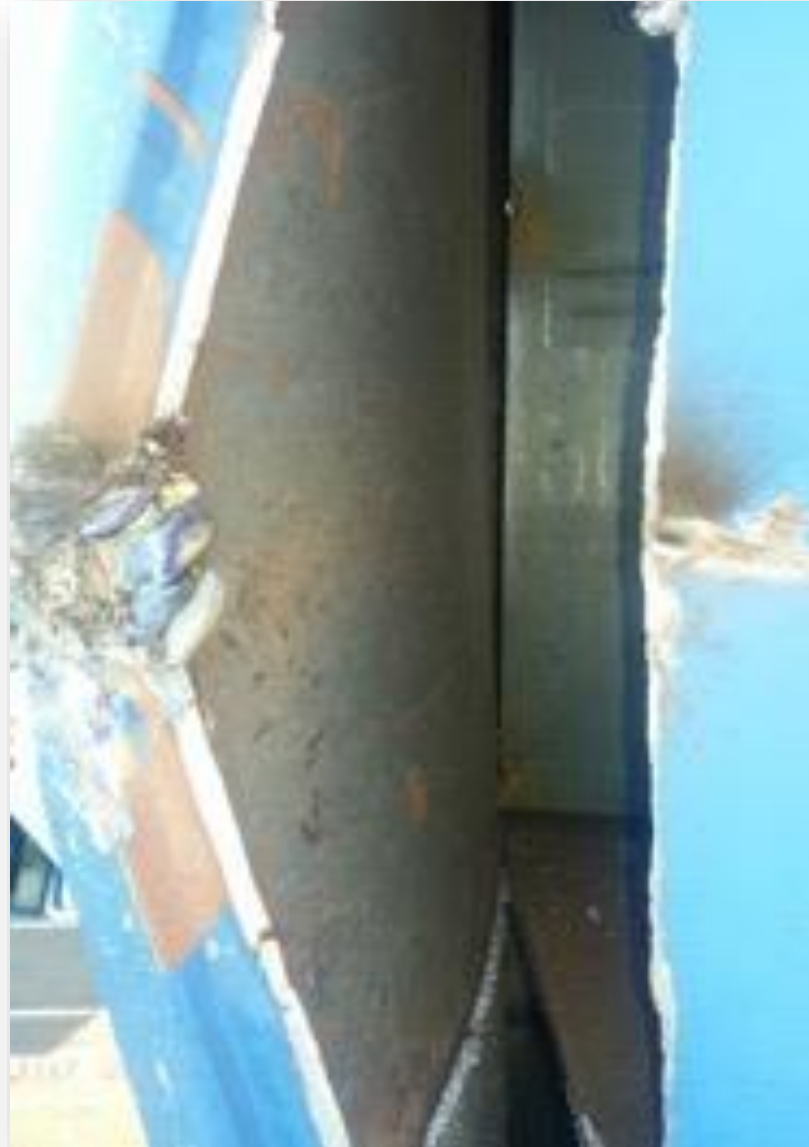
Local surveyors initial pictures of crane damage

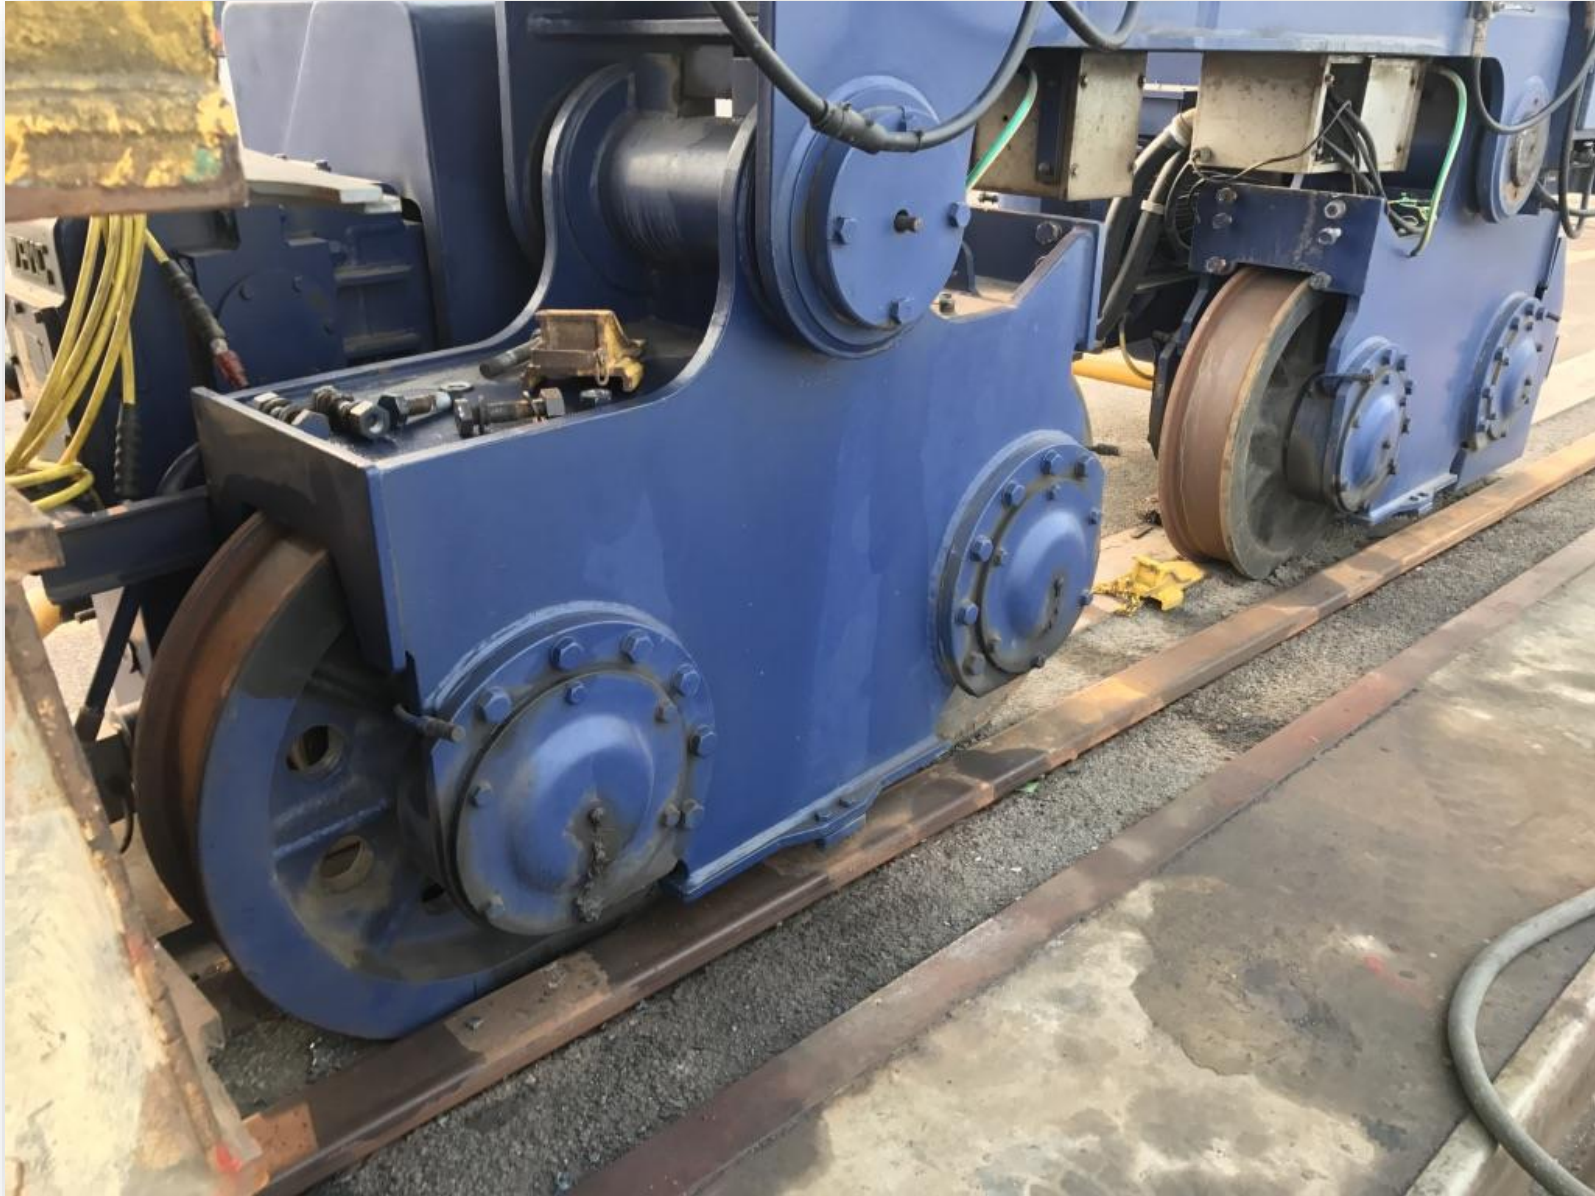
Local surveyors initial pictures of crane damage

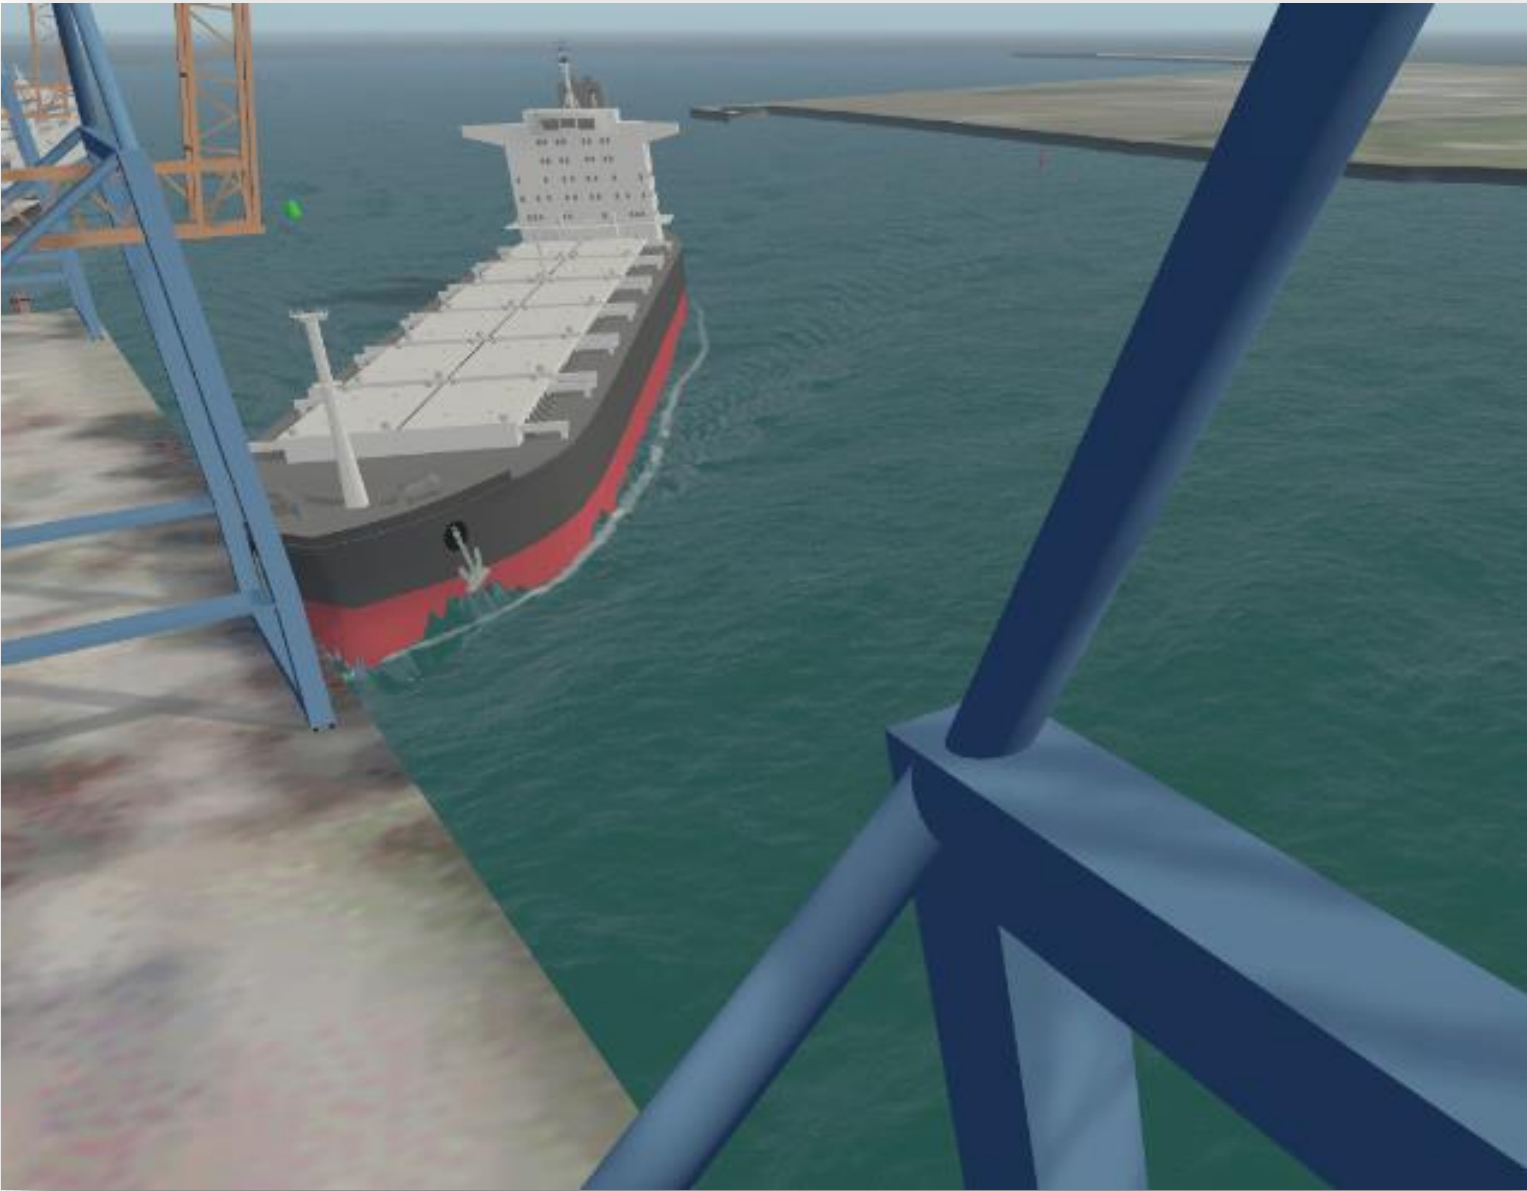
Vessel contact with Crane No. 2

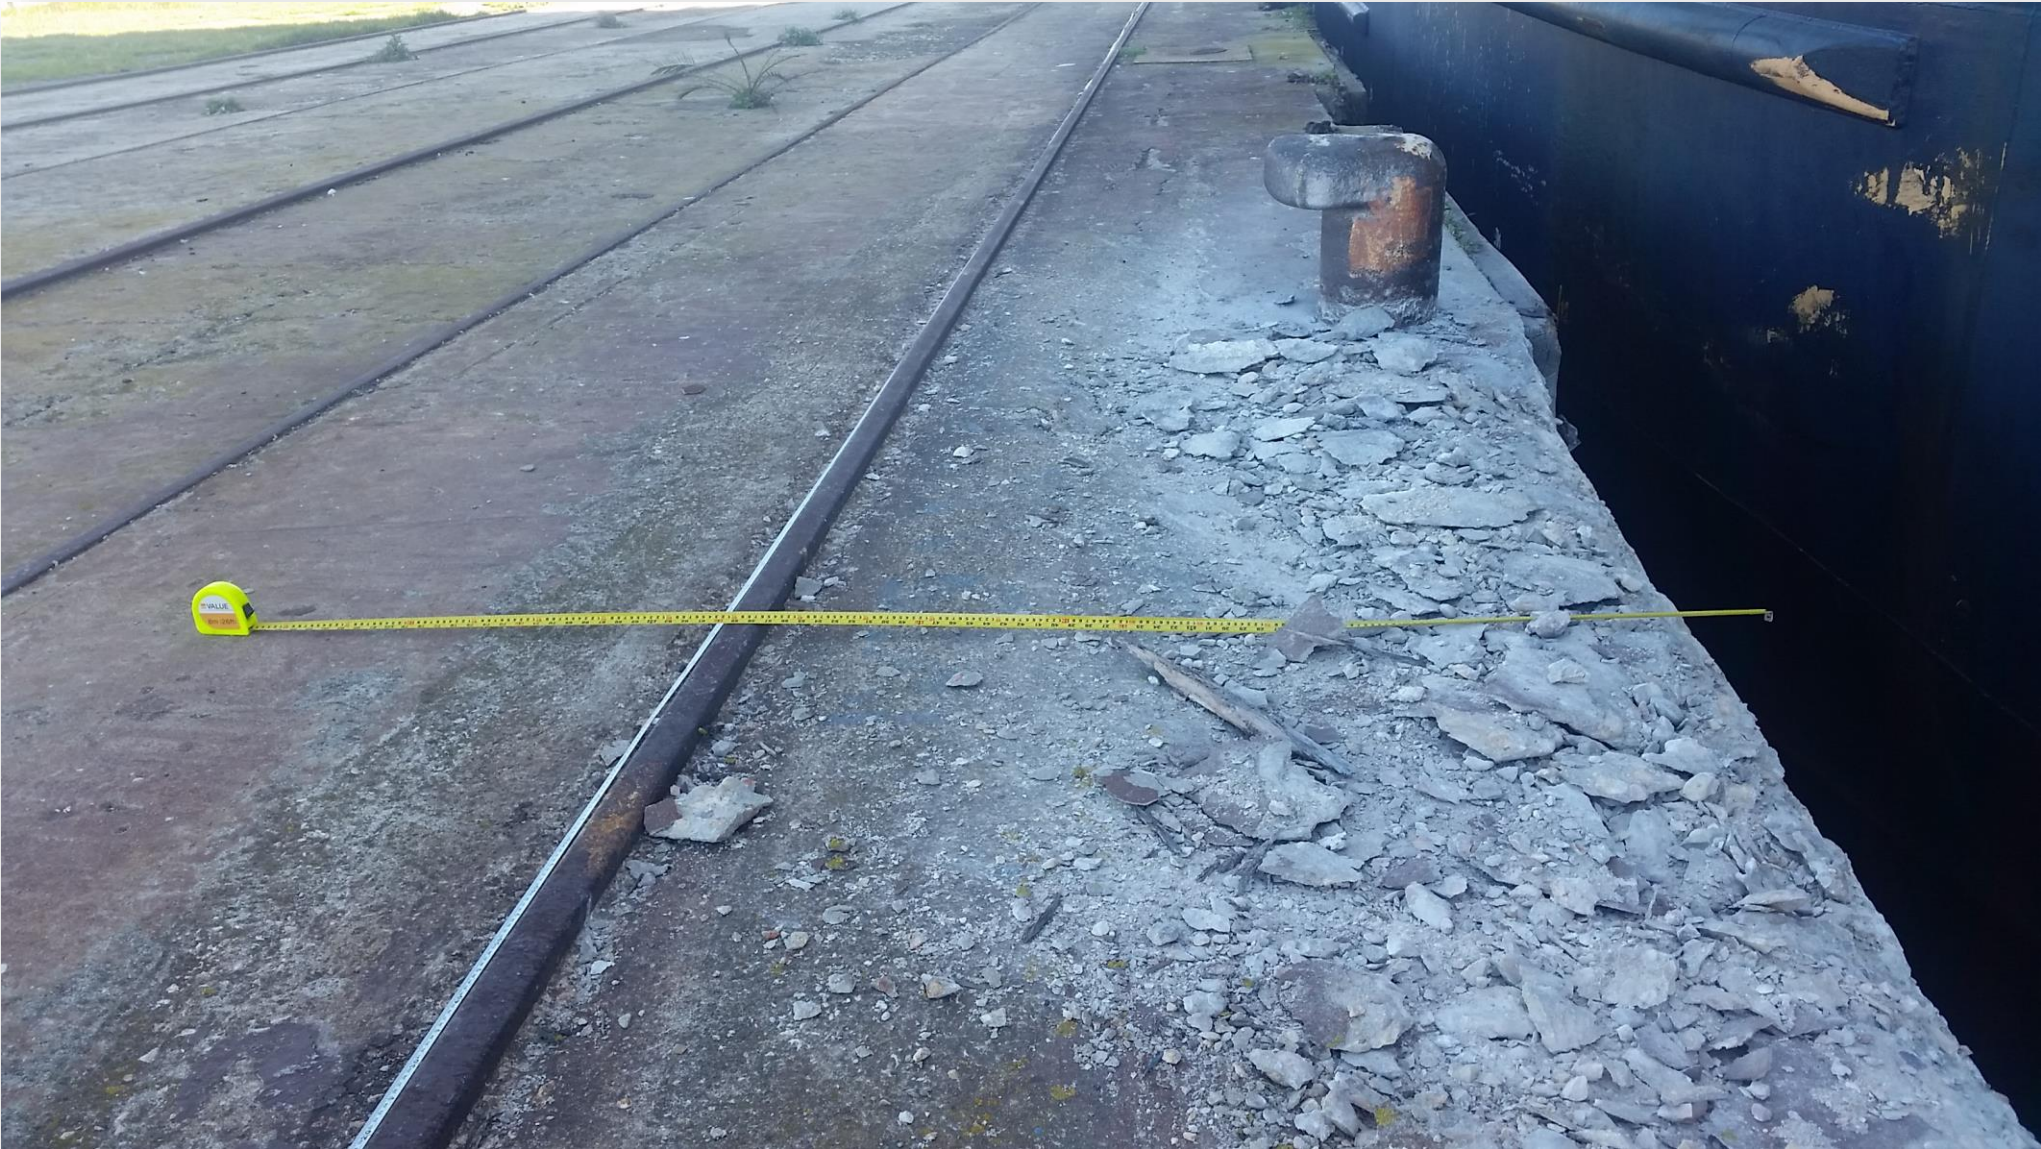
Quay deck damage that we can see

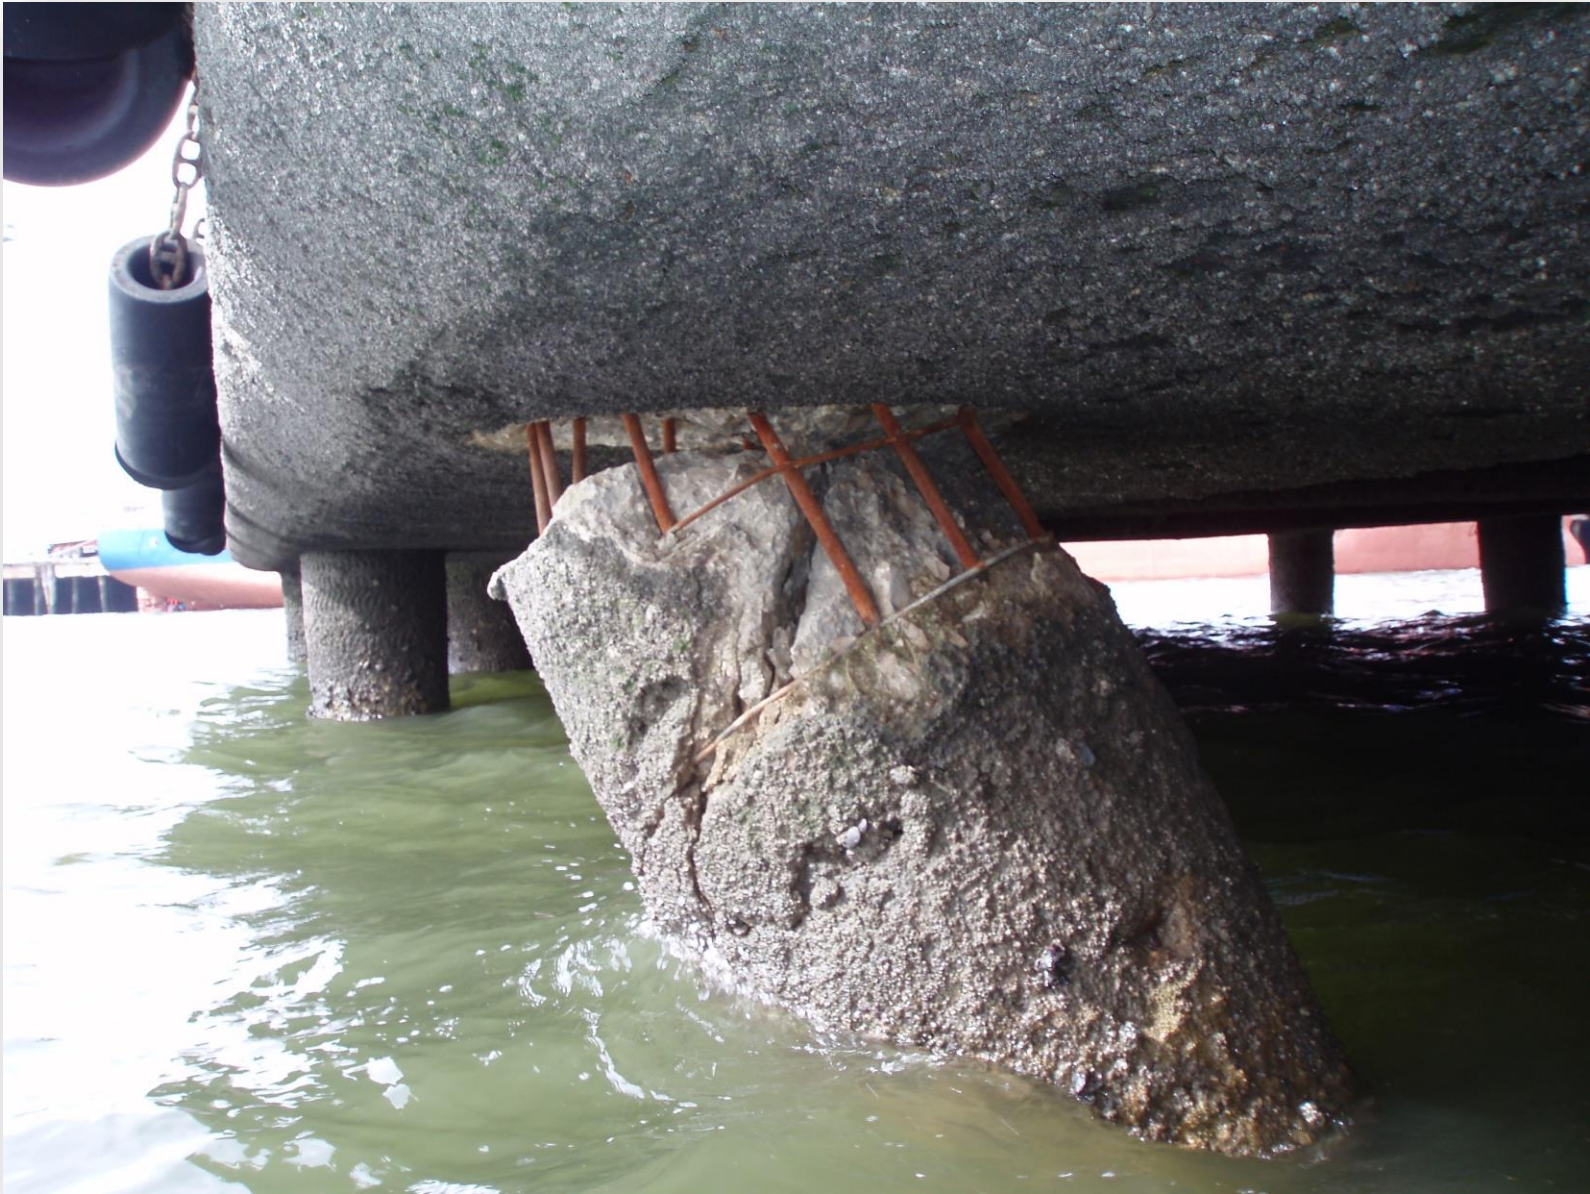
Survey under the deck and above water – vessel damage?

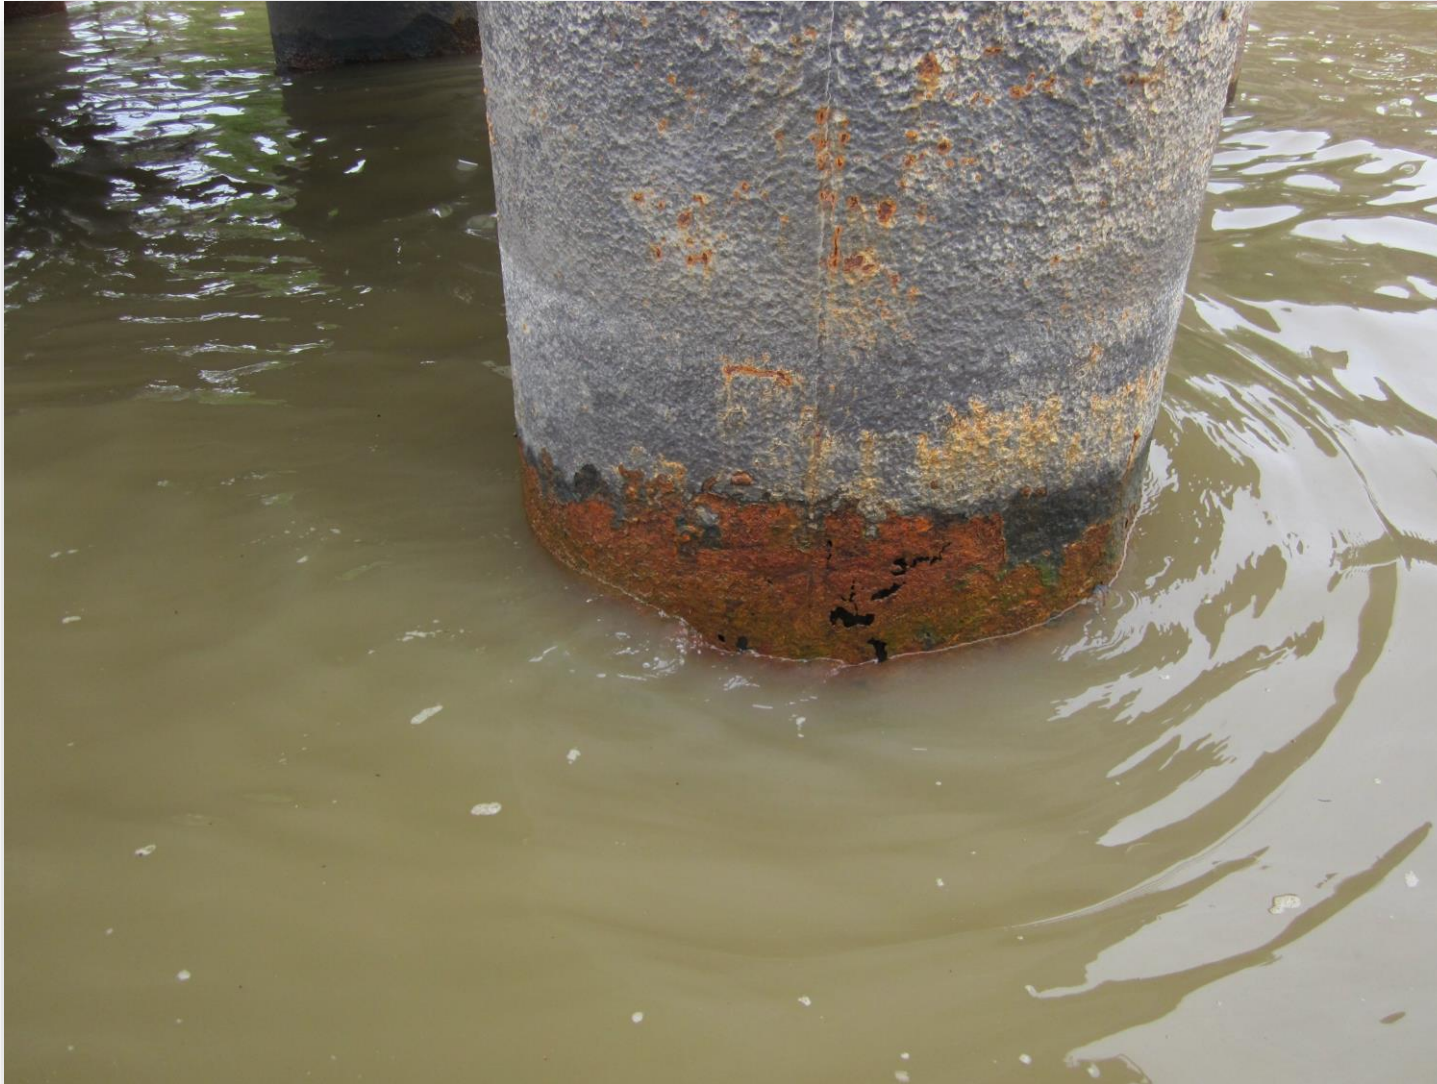
Survey under the deck and above water – corrosion

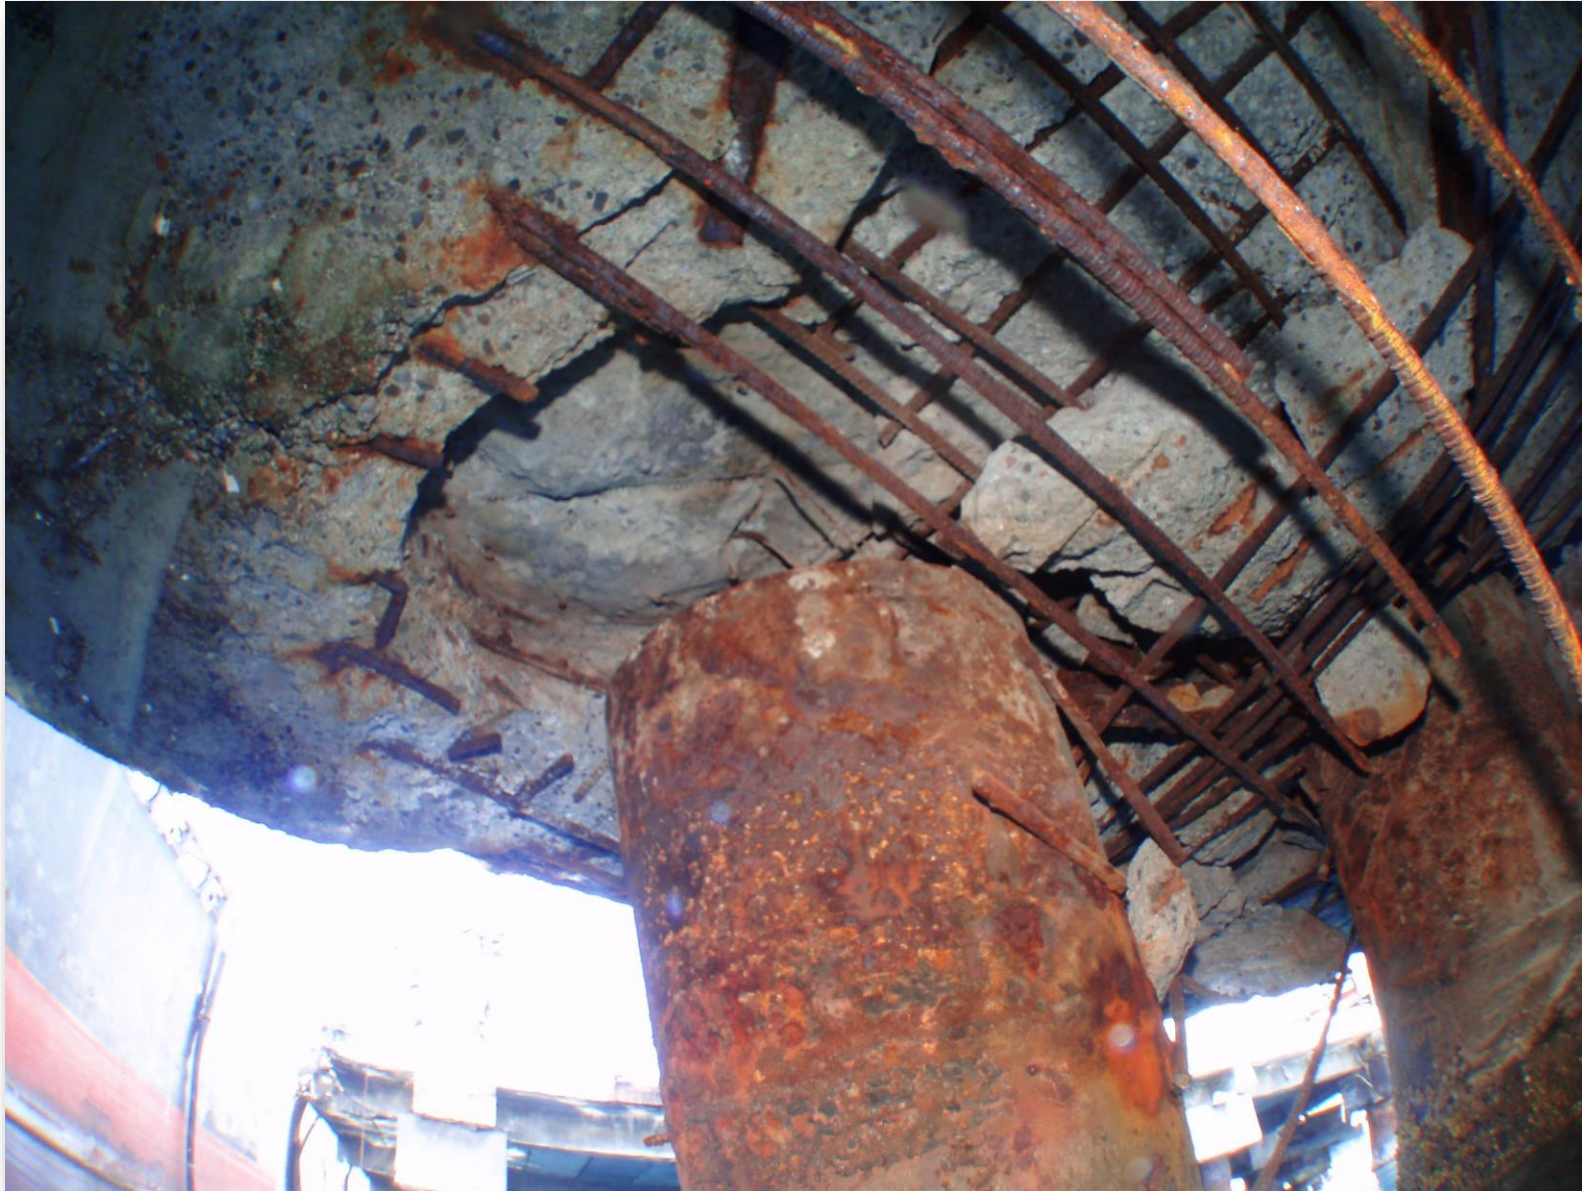
Previous contact and existing damage

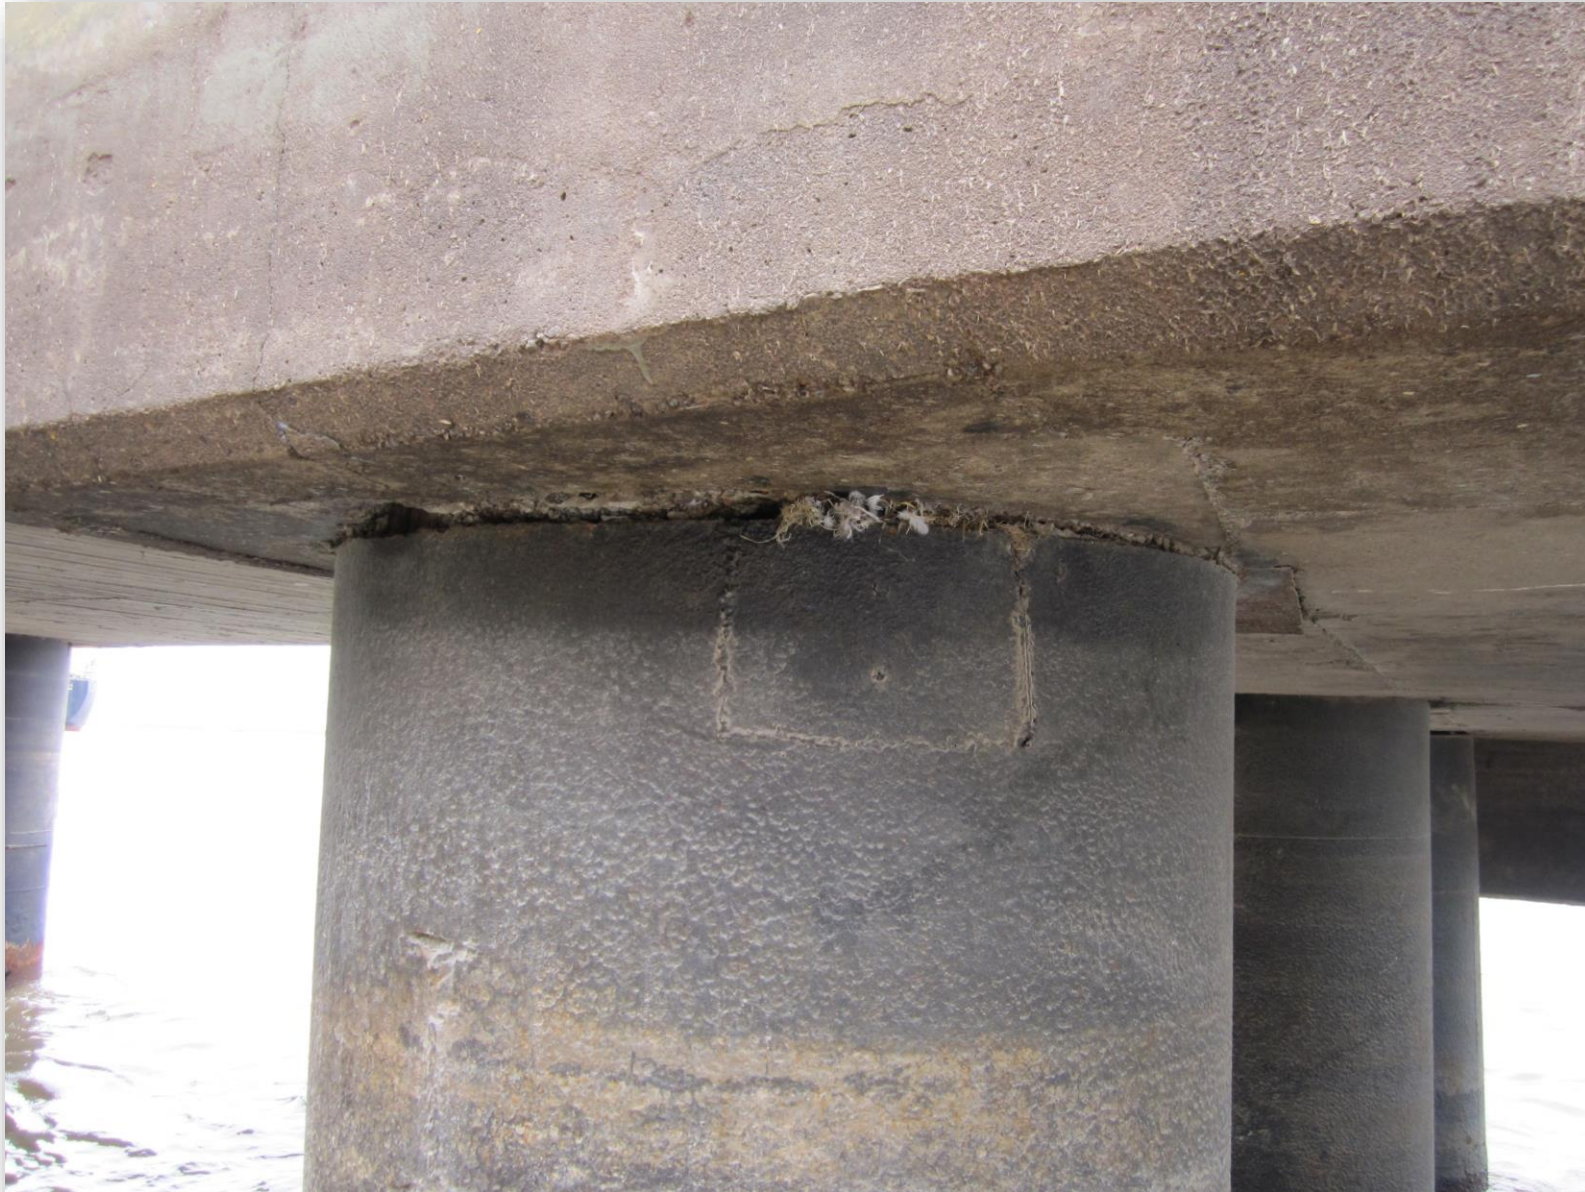
Previous contact and existing damage

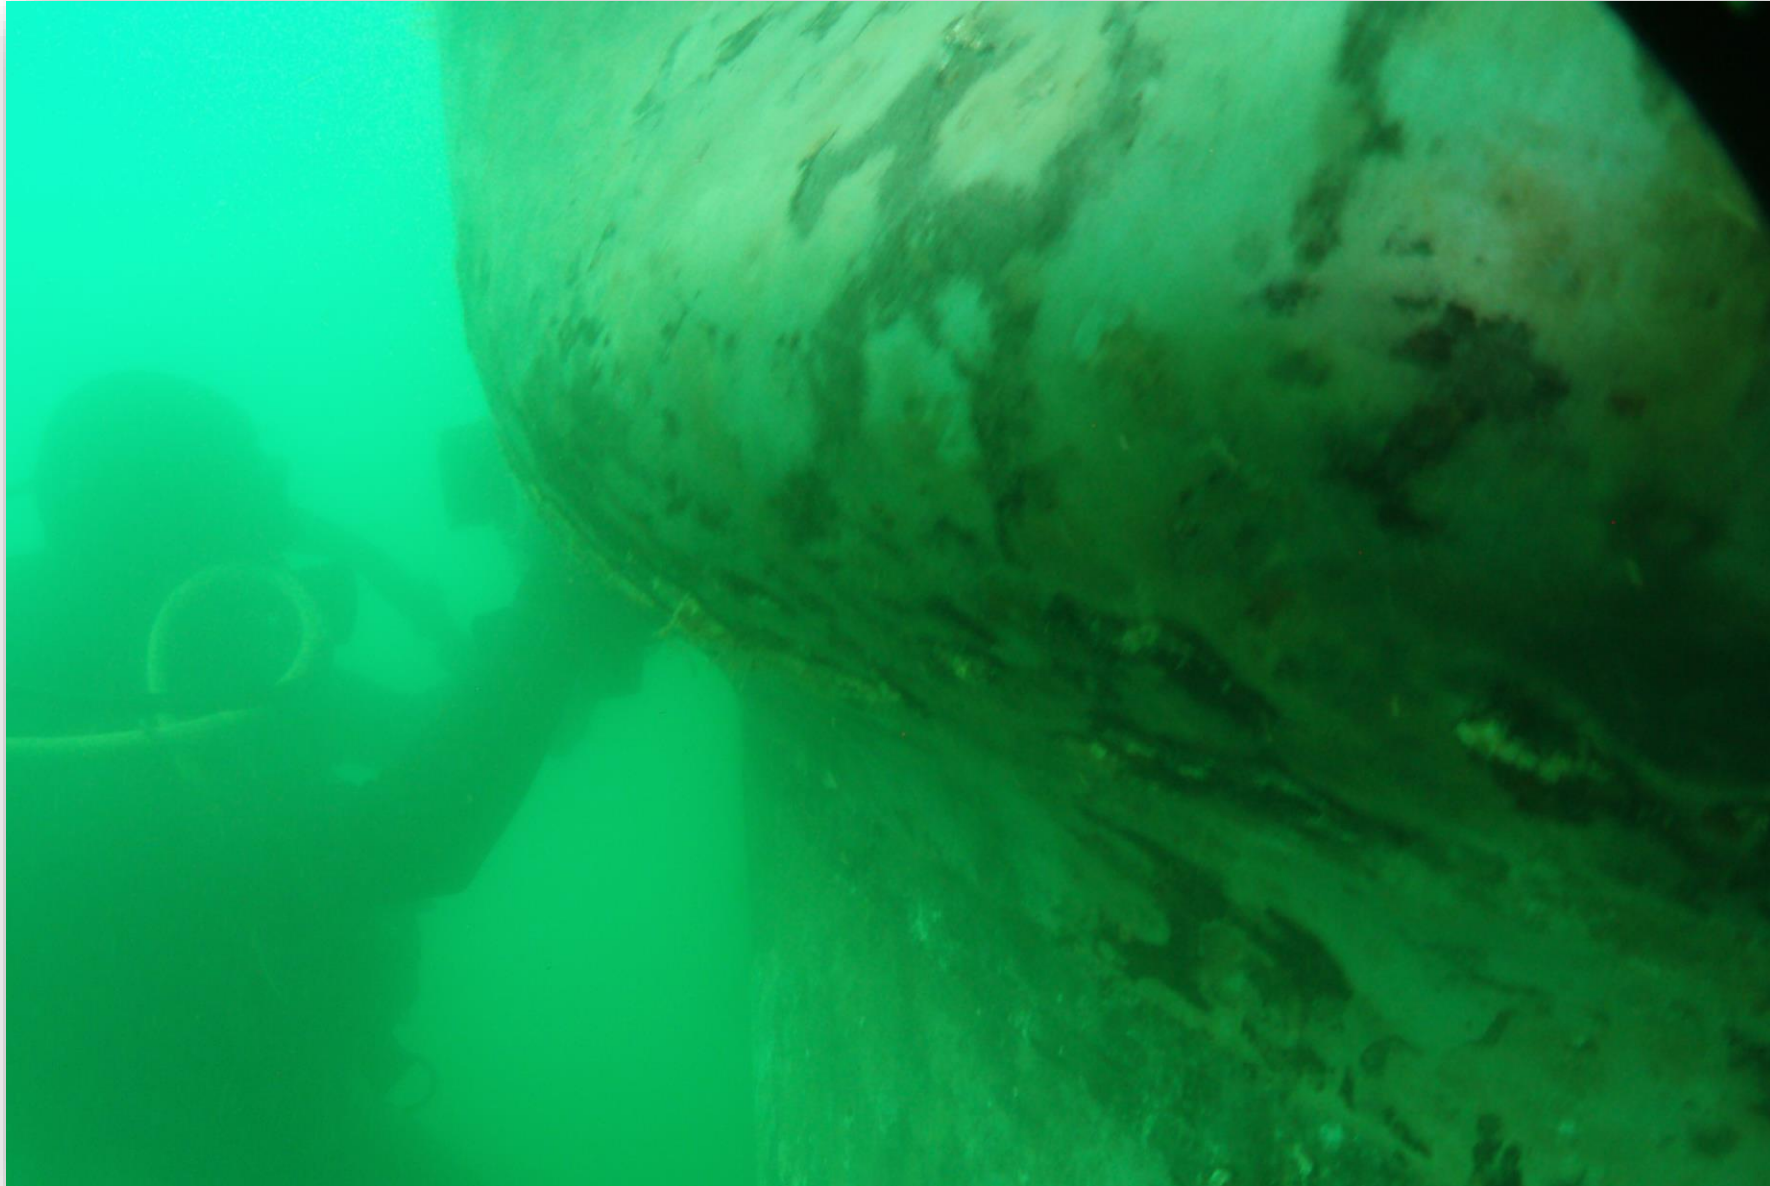
Contact damage

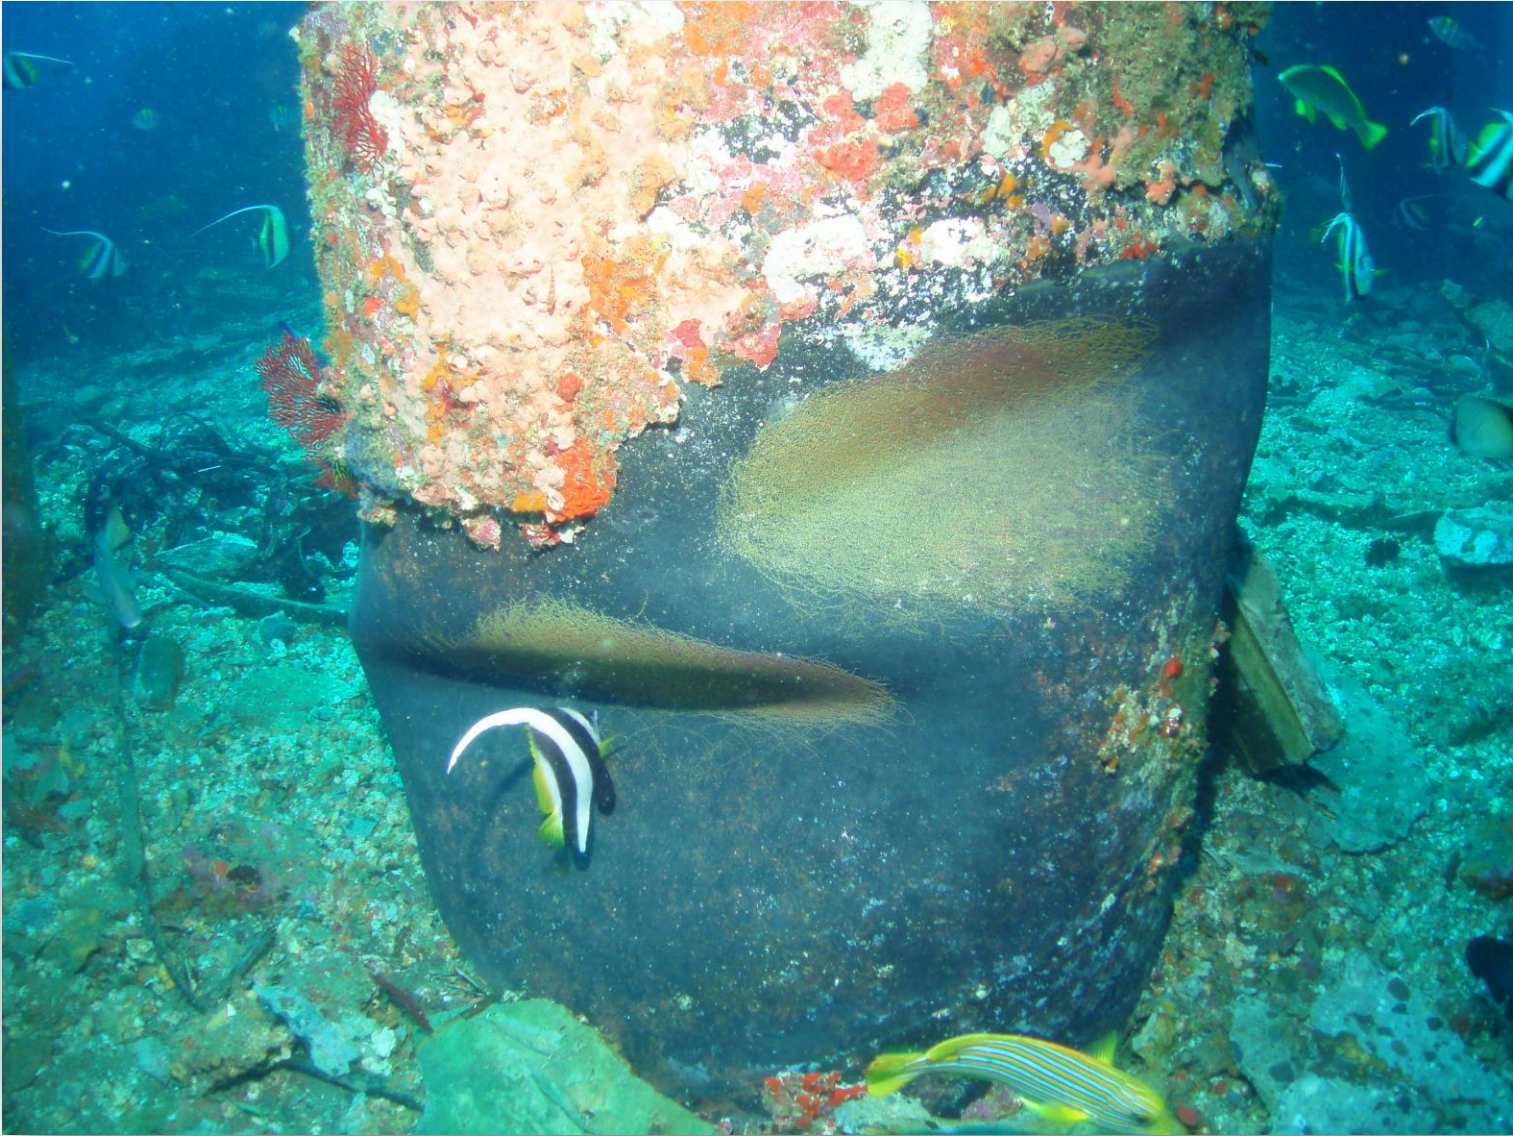
Pile buckling and overstress

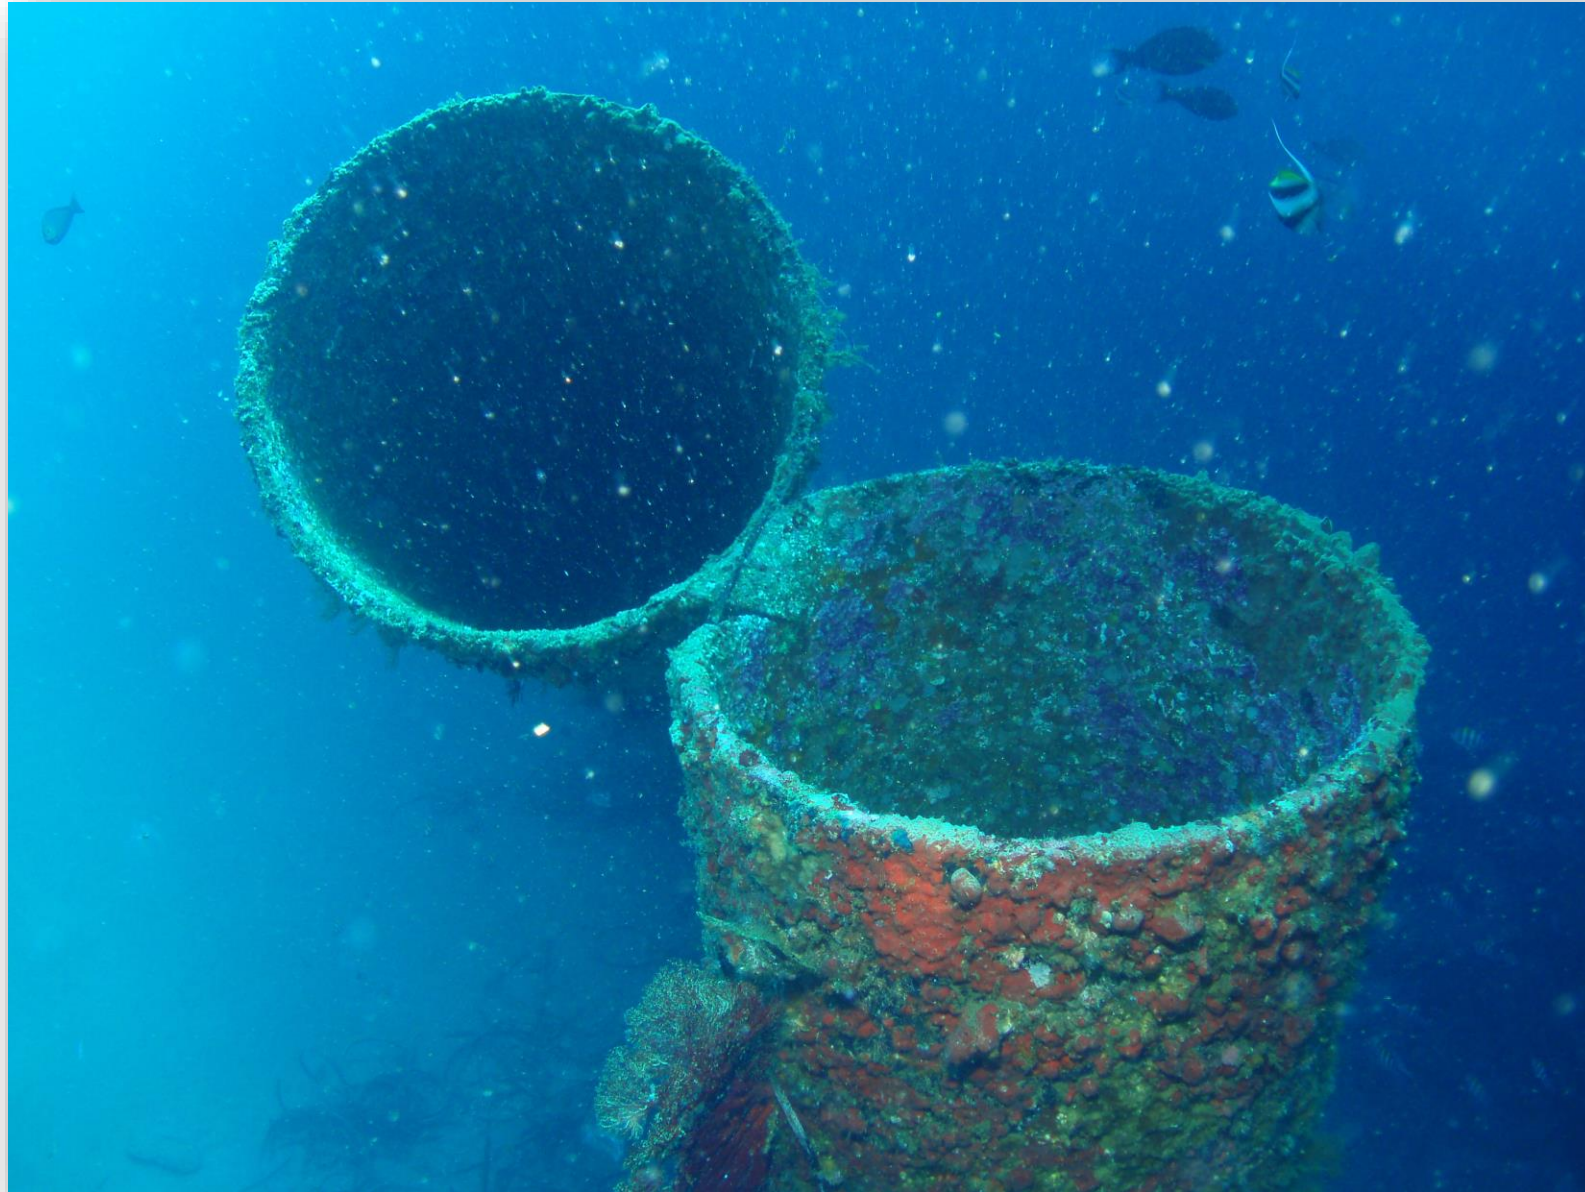
Ticking time bomb and hidden damage

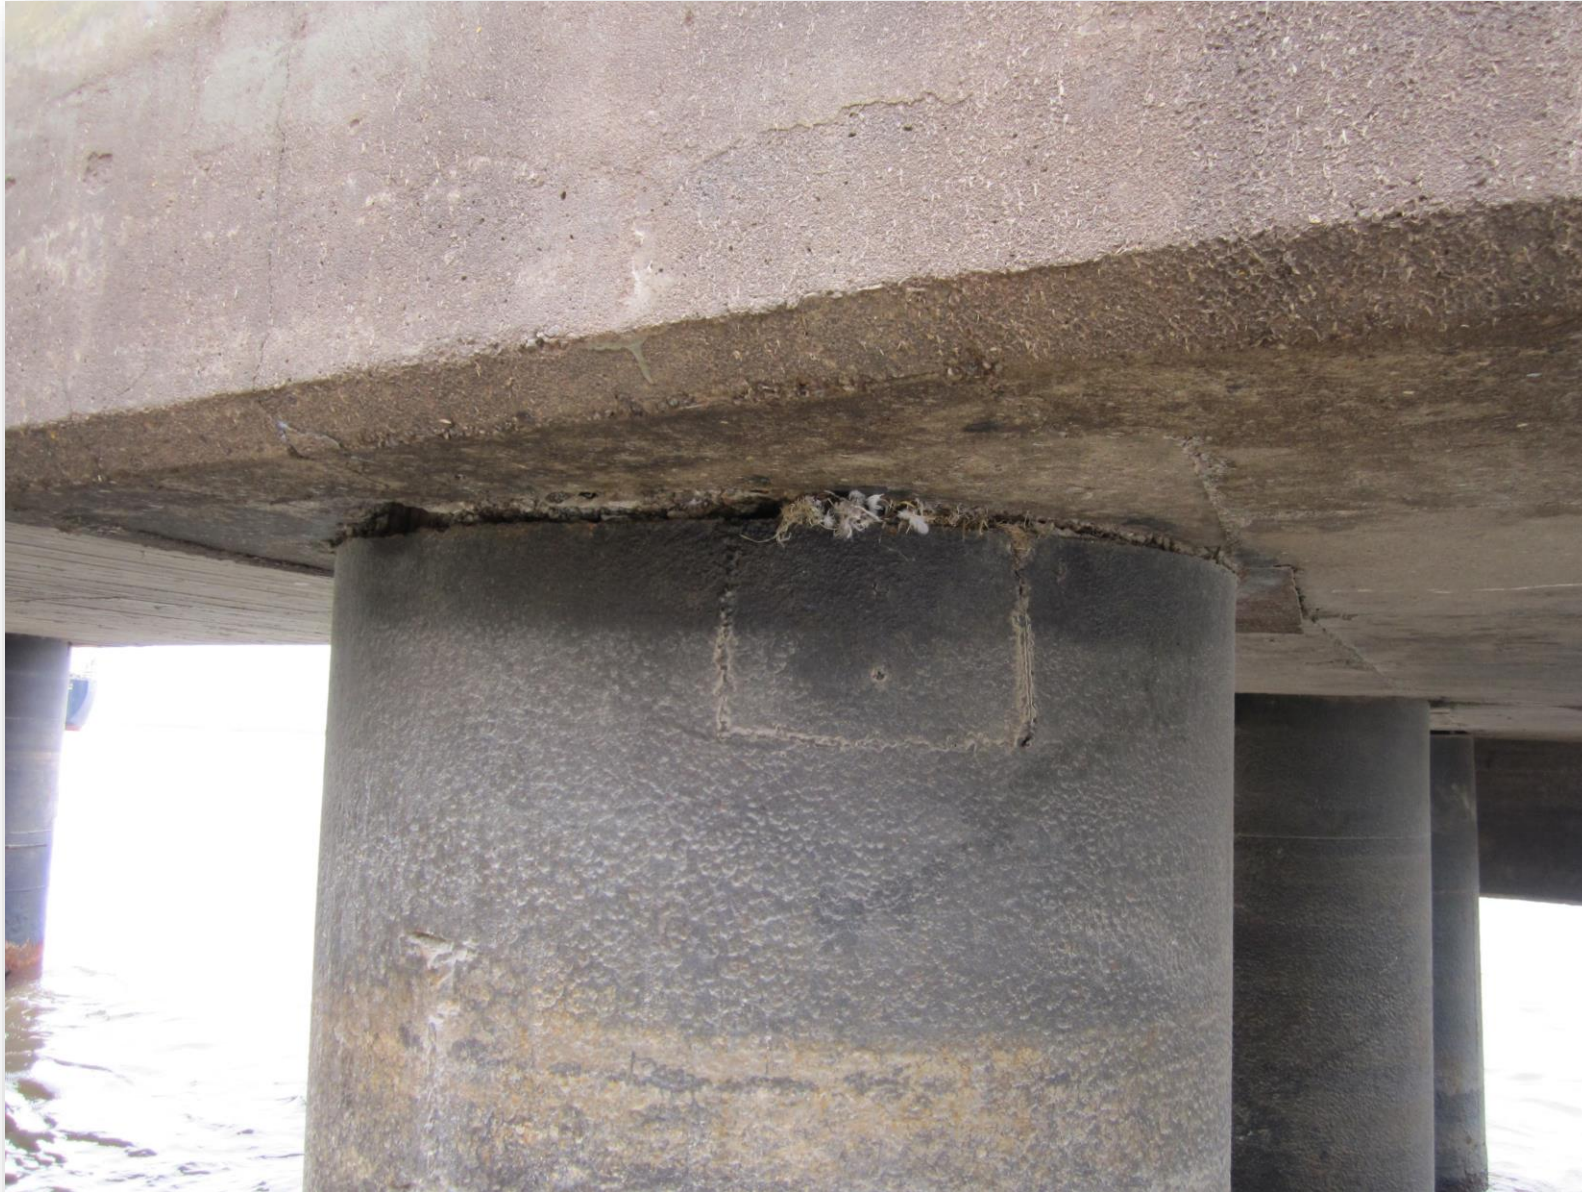
Let's have a closer look at the "bird nest pile" below water
