Cat Fine Damage

Fortuity or Inevitable?

IMCC Dublin 2018

Studio Navale Canepa

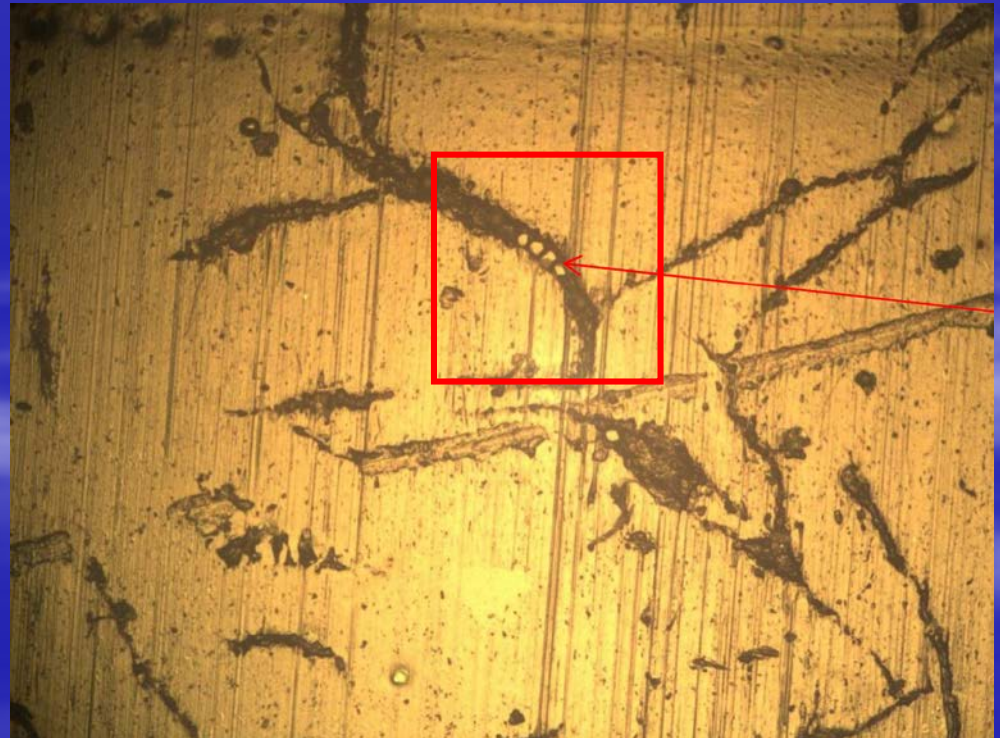
Cat fines are tiny, harder-than-steel particles contained in heavy fuels, lodging onto the running surfaces of cylinder liner and piston rings and permanently squeezed into the soft graphite lamellas.

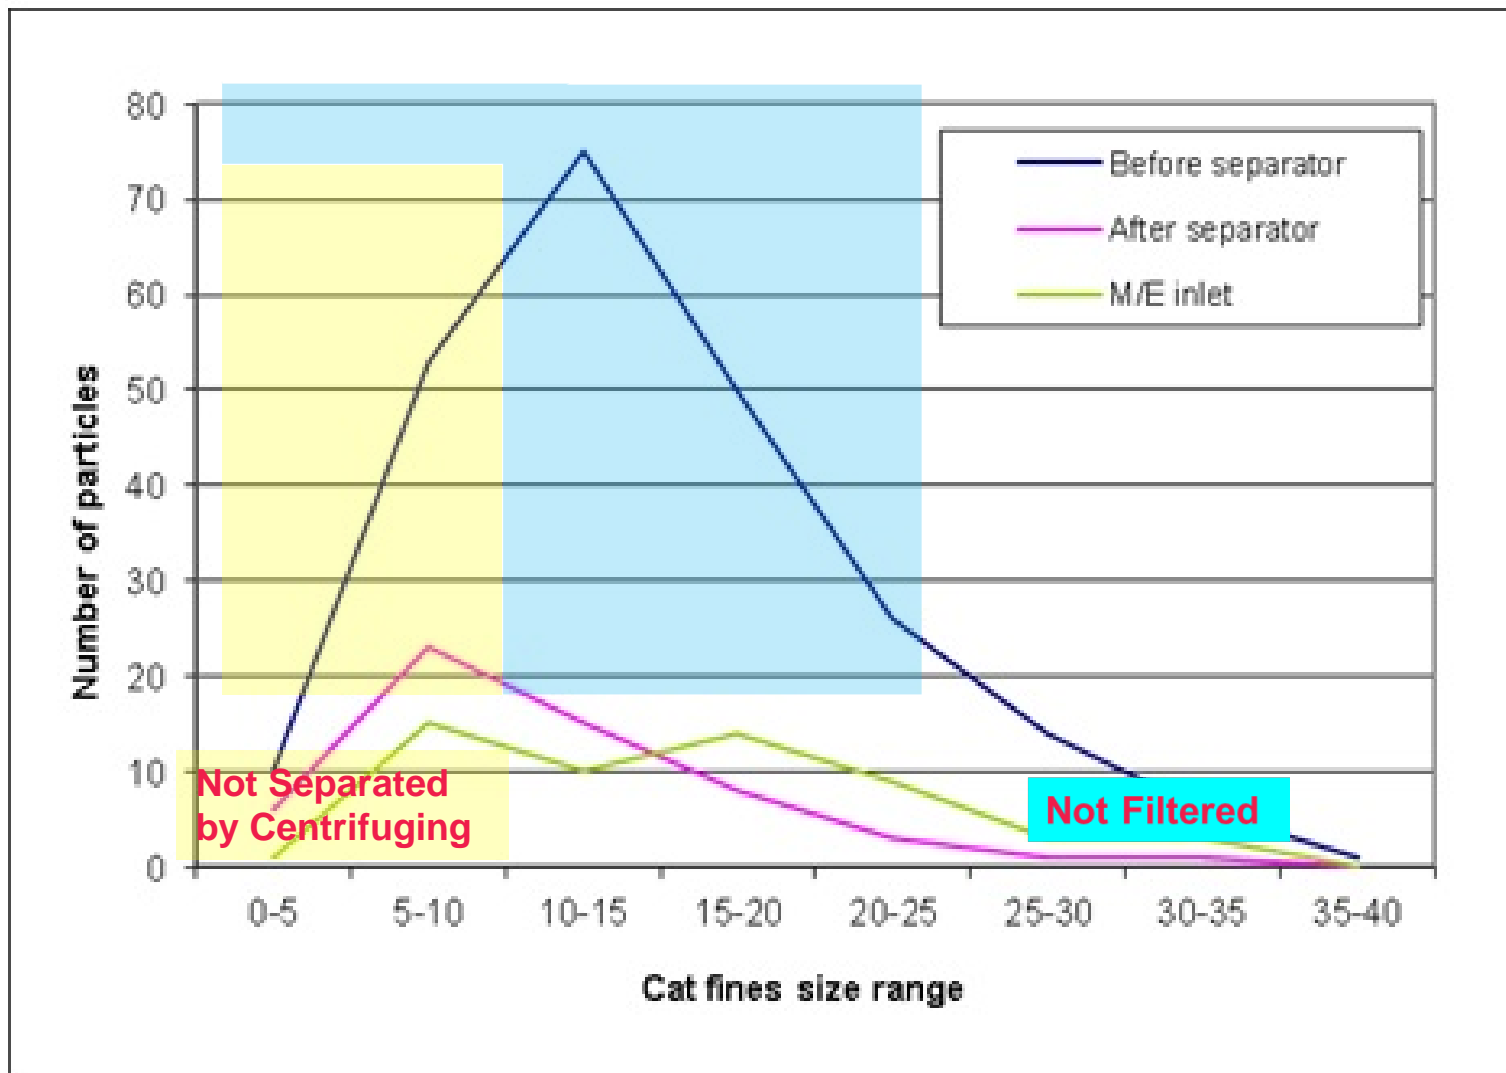
CF Distribution Diagram

Typical particle size
distribution by percent count

Size [μm]	Count [%]
1-5	30
6-15	55
16-25	10
26-50	5
>50	<0.3

The majority of cat fines fall between 5 to 15 μm in size.

Thickness of the oil film on liner walls may vary between 0.5 and 8 μm , which means that larger CF protrude through the oil film allowing metal-to-metal contact, quickly wearing both piston ring and liner wall

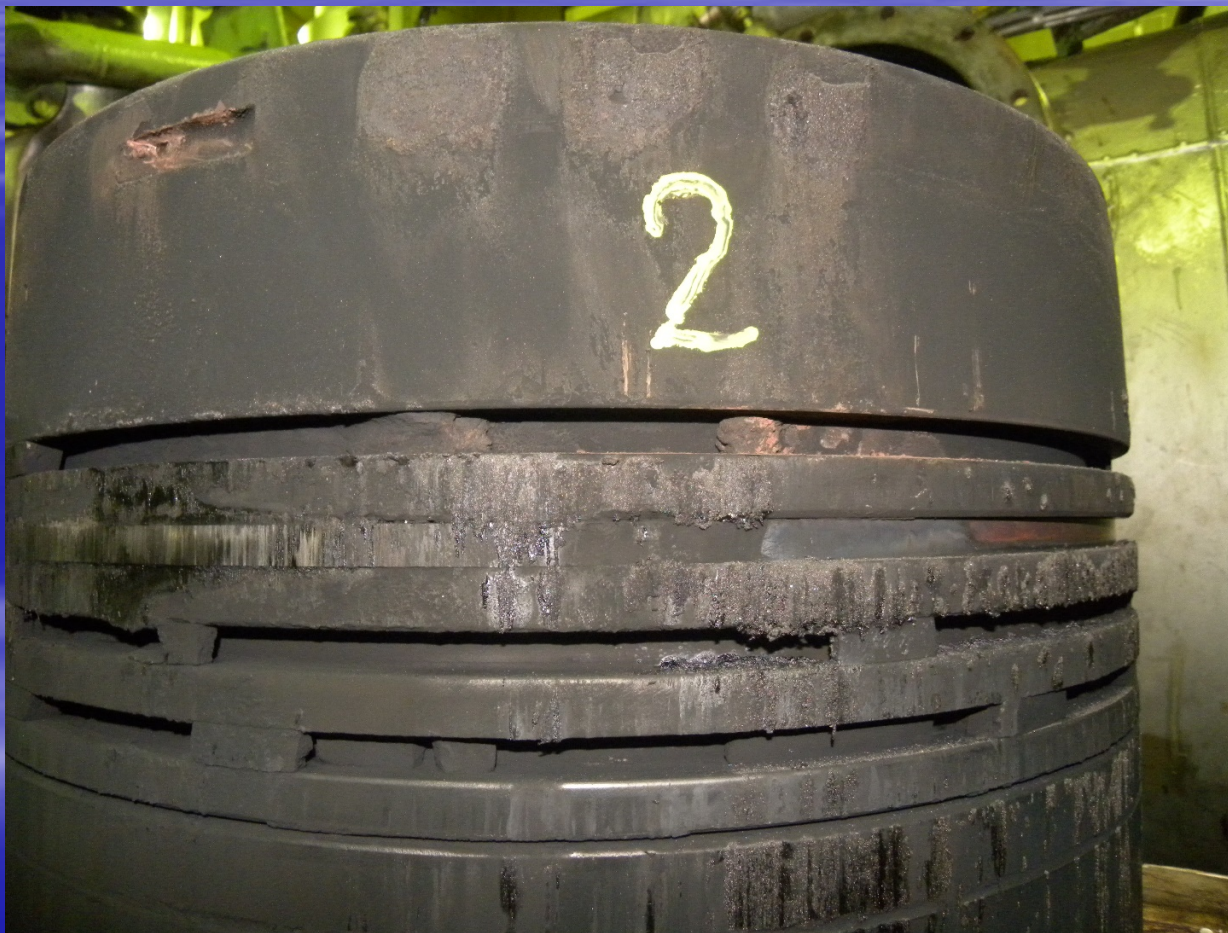
Piston crown with broken piston rings

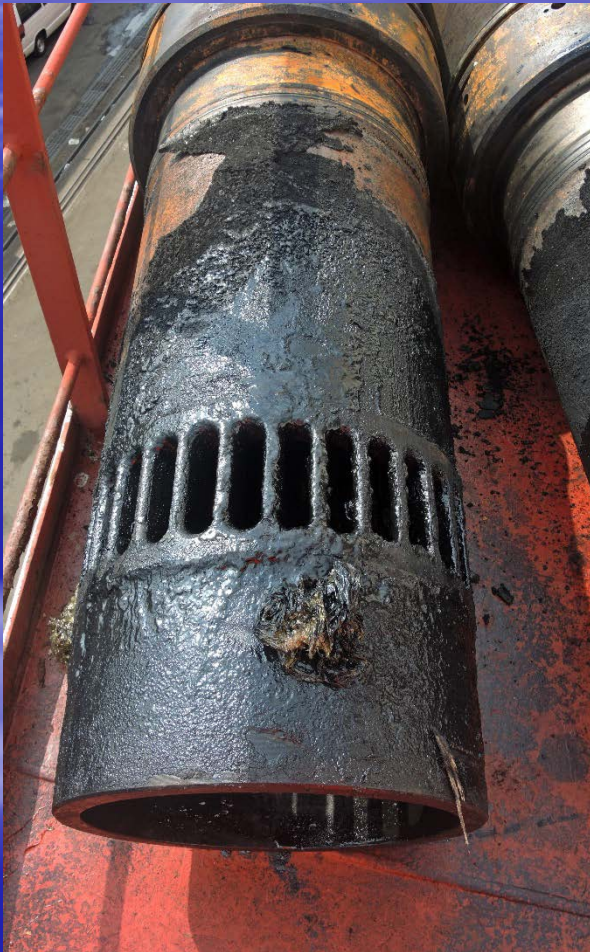
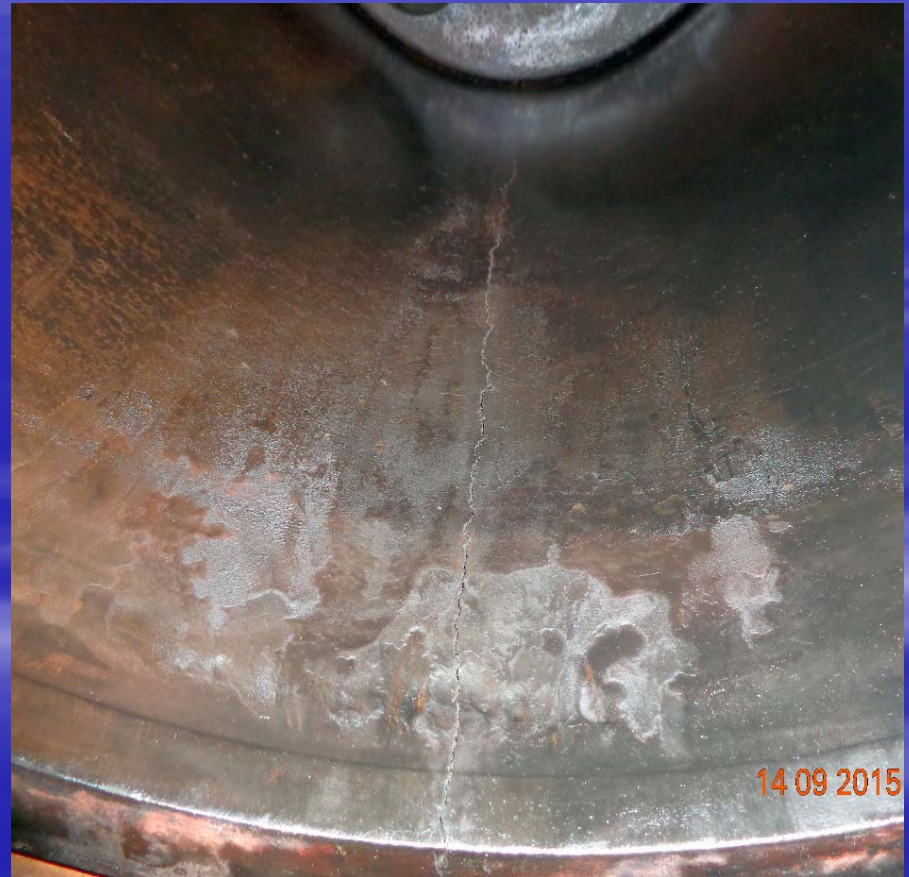
Cracked cylinder liner

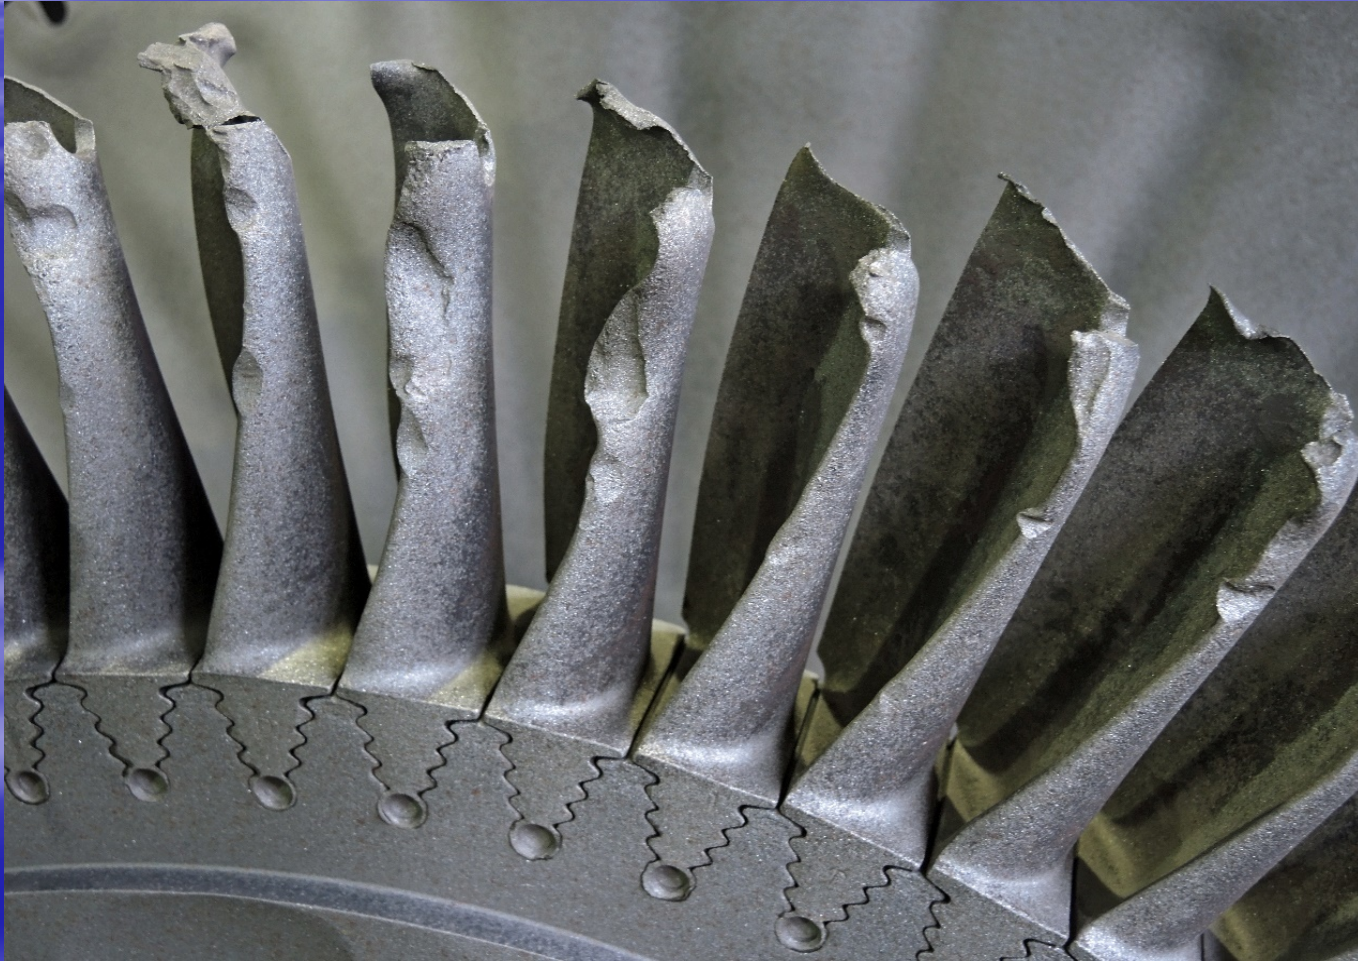
T/C blades destroyed by piston ring fragments
